POTOMAC RIVER BASIN

Name Of Dam: <sup>3</sup>STRABURG *Dam*  
Location: SHENANDOAH COUNTY, STATE OF VIRGINIA  
Inventory Number: VA 17105

**LEVEL II**  
**PHASE I INSPECTION REPORT**  
**NATIONAL DAM SAFETY PROGRAM.**

AUGUST 1978

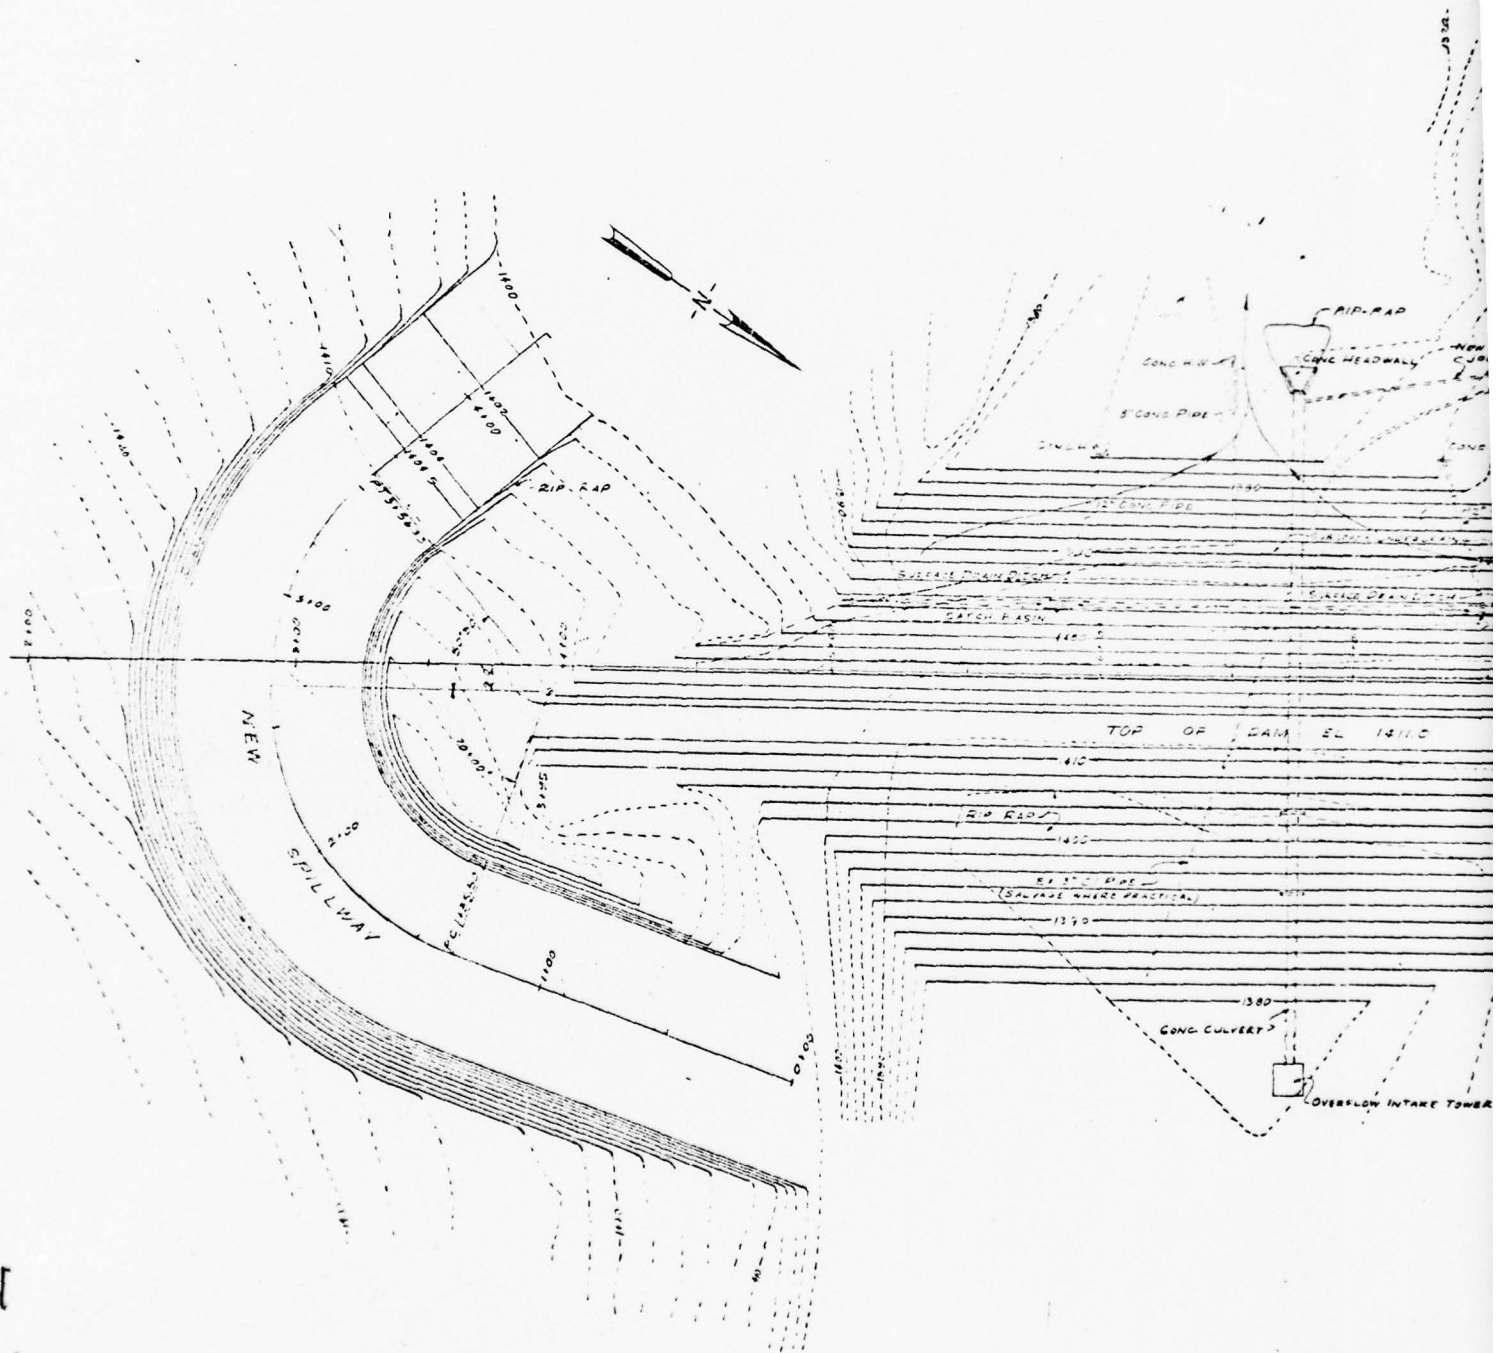
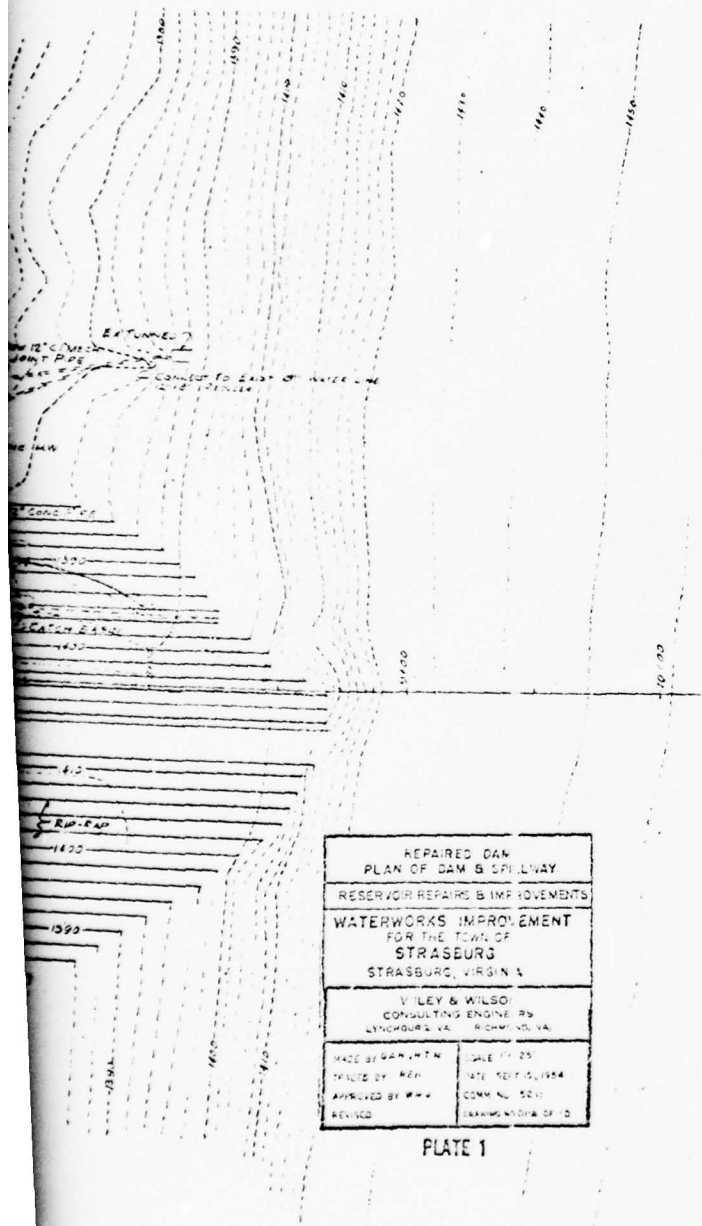
PLATE 1

REPAIRED DAM PLAN OF DAM & SPILLWAY	
RESERVOIR REPAIRS & IMPROVEMENTS	
WATERWORKS IMPROVEMENT FOR THE TOWN OF STRASBURG STRASBURG, VIRGINIA	
VILEY & WILSON CONSULTING ENGINEERS LYNCHBURG, VA. RICHMOND, VA.	
MADE BY KAN, H.T.M.	SCALE 1" = 25'
TRACED BY K.E.H.	DATE SET 10/15/54
APPROVED BY W.W.V.	COMM. NO. 5011
REVISED	EXAMINATION OF 10/15

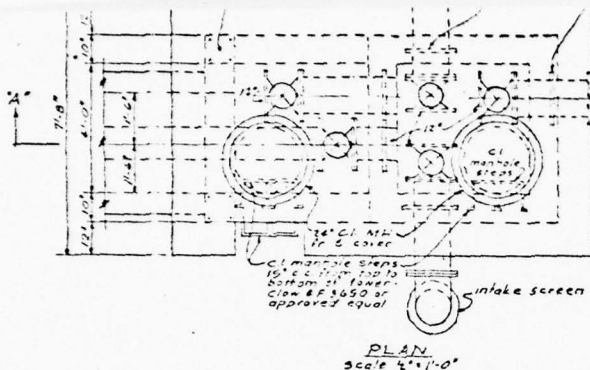
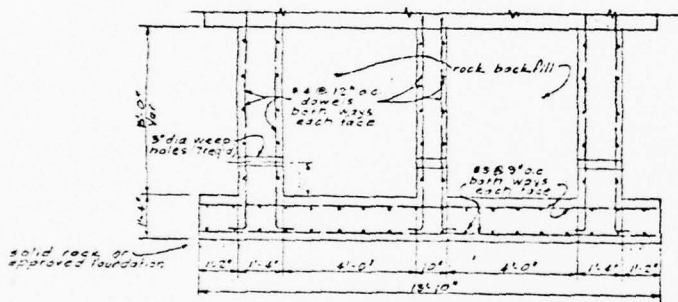
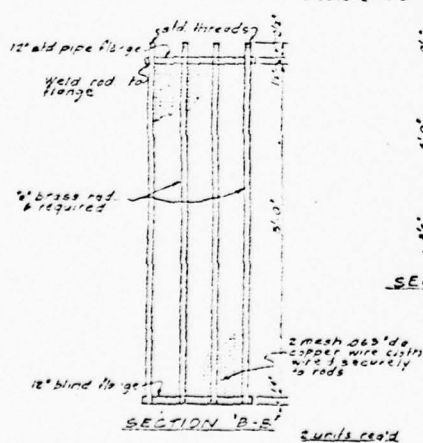
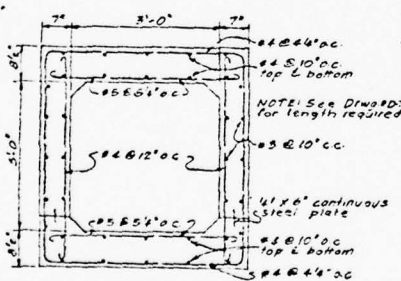
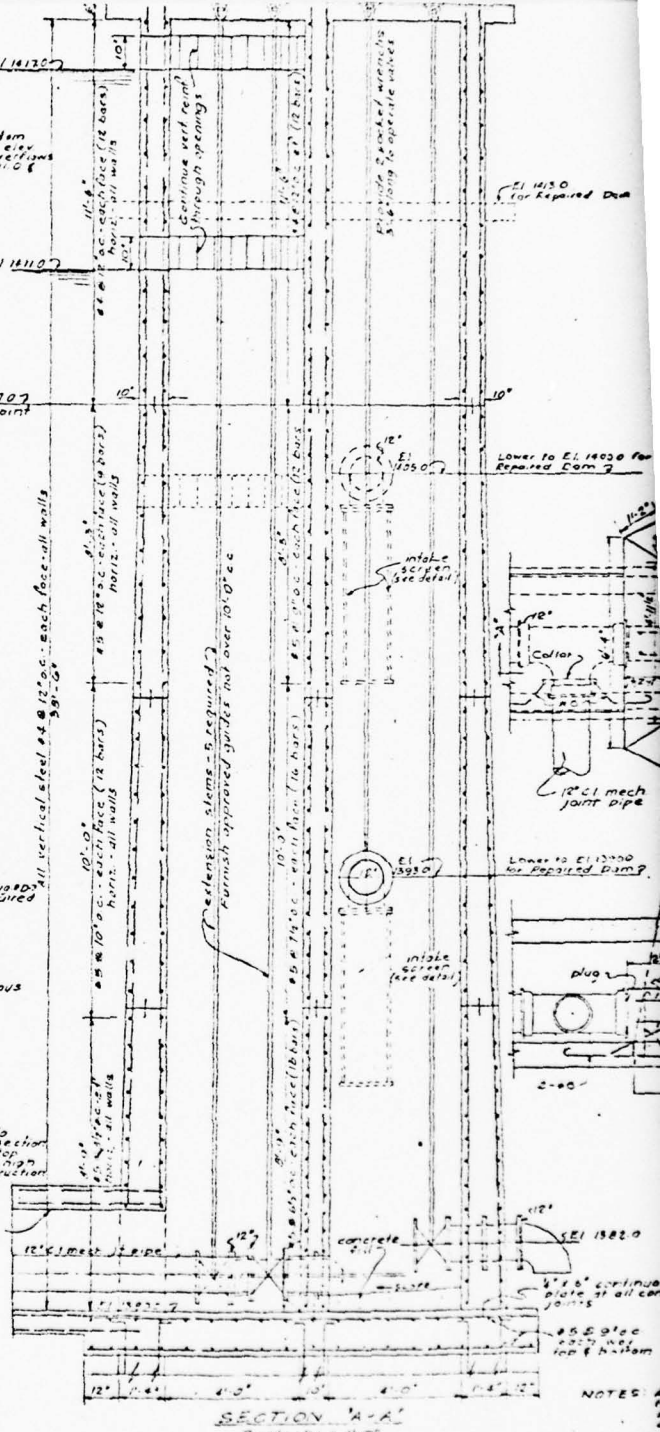
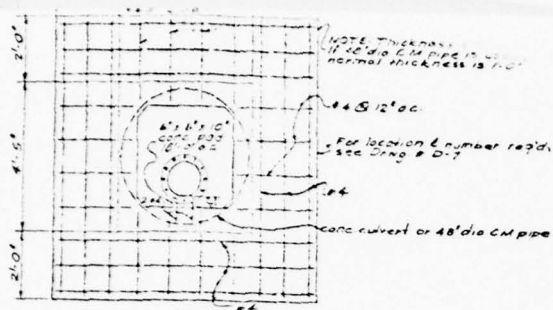
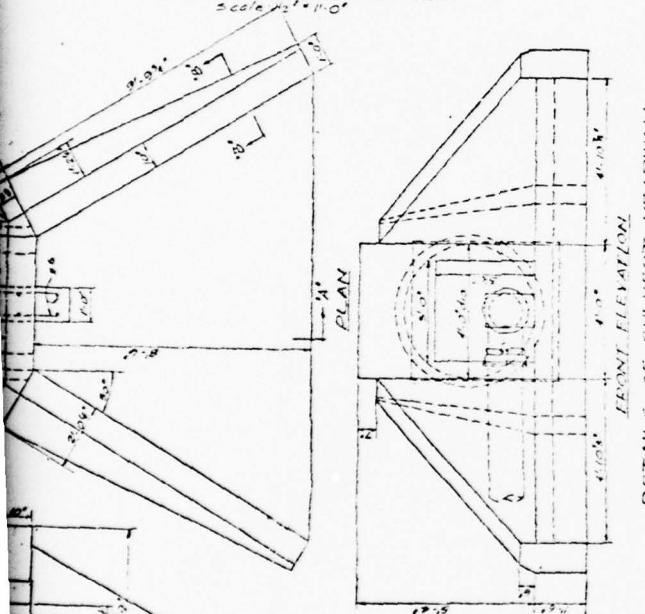
PLATE 3

OVERFLOW INTAKE TOWER DETAILS
